# NATIONAL BUREAU OF STANDARDS REPORT

9647

PERFORMANCE OF CONVERSION COATINGS ON MAGNESIUM ALLOYS  
IN MARINE AND SALT SPRAY (FOG) ENVIRONMENTS

W. F. Gerhold  
Engineering Metallurgy Section

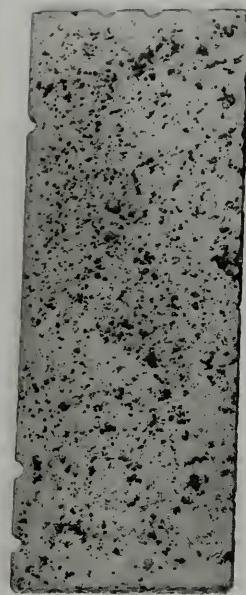
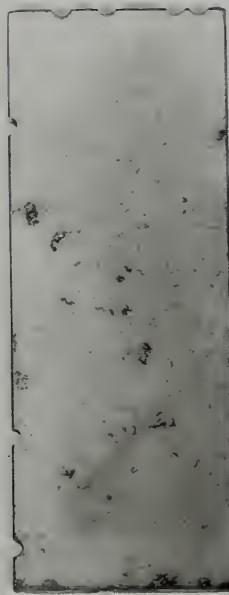
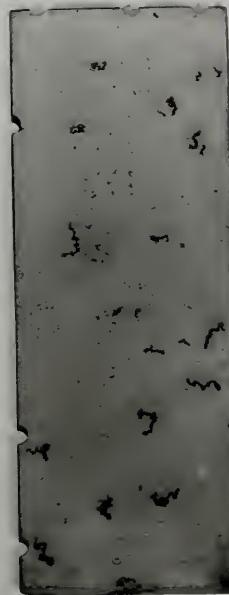
Deterioration of all of the coatings on either alloy was characterized by localized failures of the coating followed by subsequent pitting of the base metal. This is shown in figure 1 for the wrought AZ31A-H24 magnesium alloy and in figure 2 for the sand cast AZ91C-T6 magnesium alloy. The declining order of the coatings, arranged according to the protection given is in Table 4.

Figure 1. Appearance of representative surface treated wrought AZ31A-H24 magnesium alloy specimens after 1000 hours exposure in salt spray and after cleaning to remove corrosion products and conversion coatings. X 1/4.

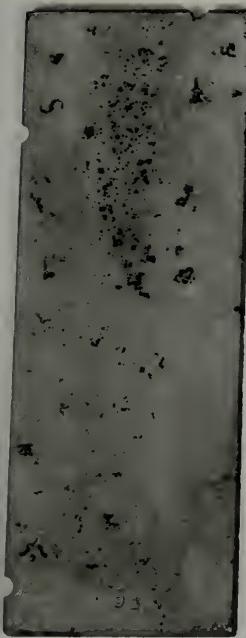
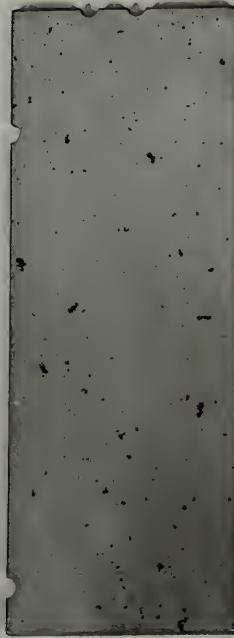
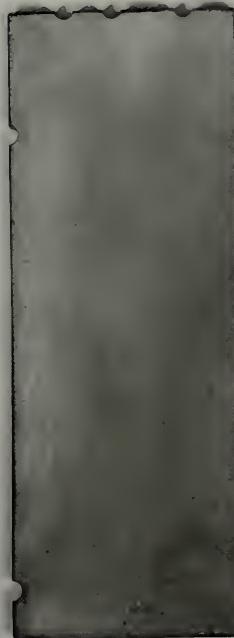
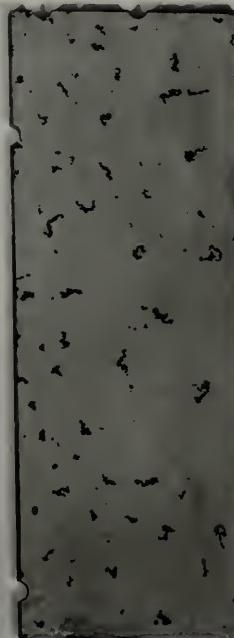
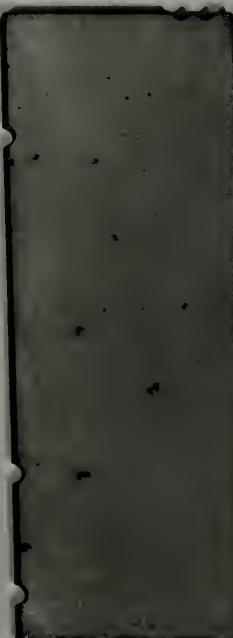
Figure 2. Representative surface treated sand cast AZ91C-T6 magnesium alloy specimens after 1000 hours exposure in the salt spray and after cleaning to remove corrosion products and conversion coatings. X 1/3.
